Evaluating Fire-Damaged Components of Historic Covered Bridges

Forest Service
Forest Products Laboratory
General Technical Report
FPL-GTR-243
August 2016

A FHWA-NHCBP (National Historic Covered Bridge Program) publication

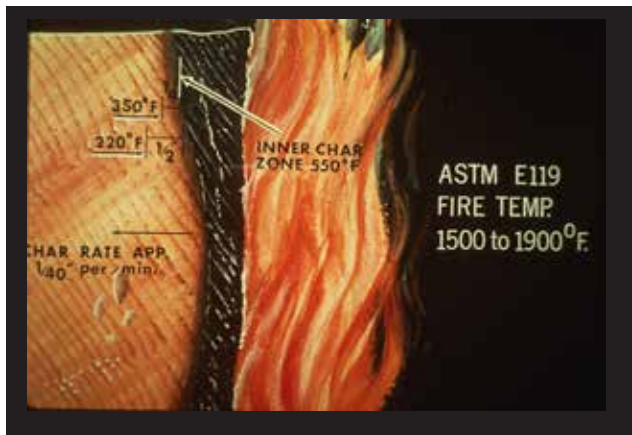
Figure 4—Illustration of a charring wood member exposed to the standard fire exposure of 815 to 1,038 °C.

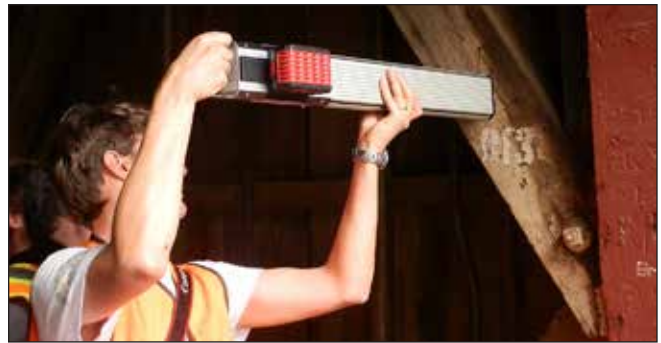
Figure 6—Field test using commercial drill resistance test equipment.

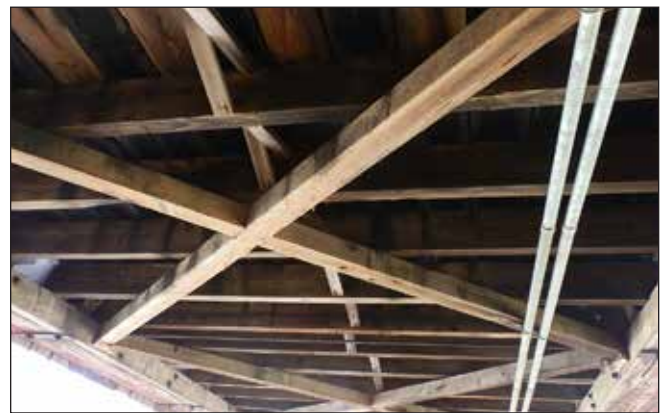
Figure 10—Underside of bridge deck, Red Covered Bridge.

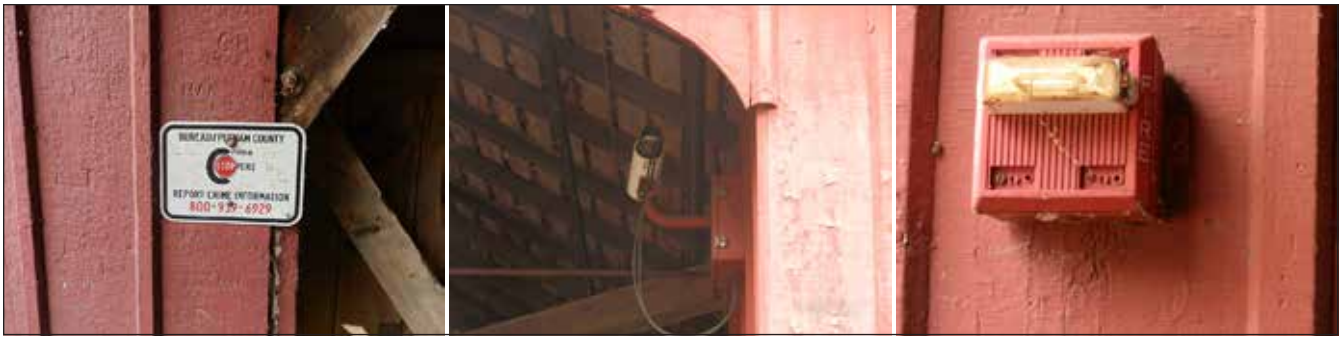
Figure 11—Examples of fire deterrent and notification techniques used on the Red Covered Bridge, circa 2012.
